24" Caisson Liner 95m Long | Piper Bravo, North Sea, UK

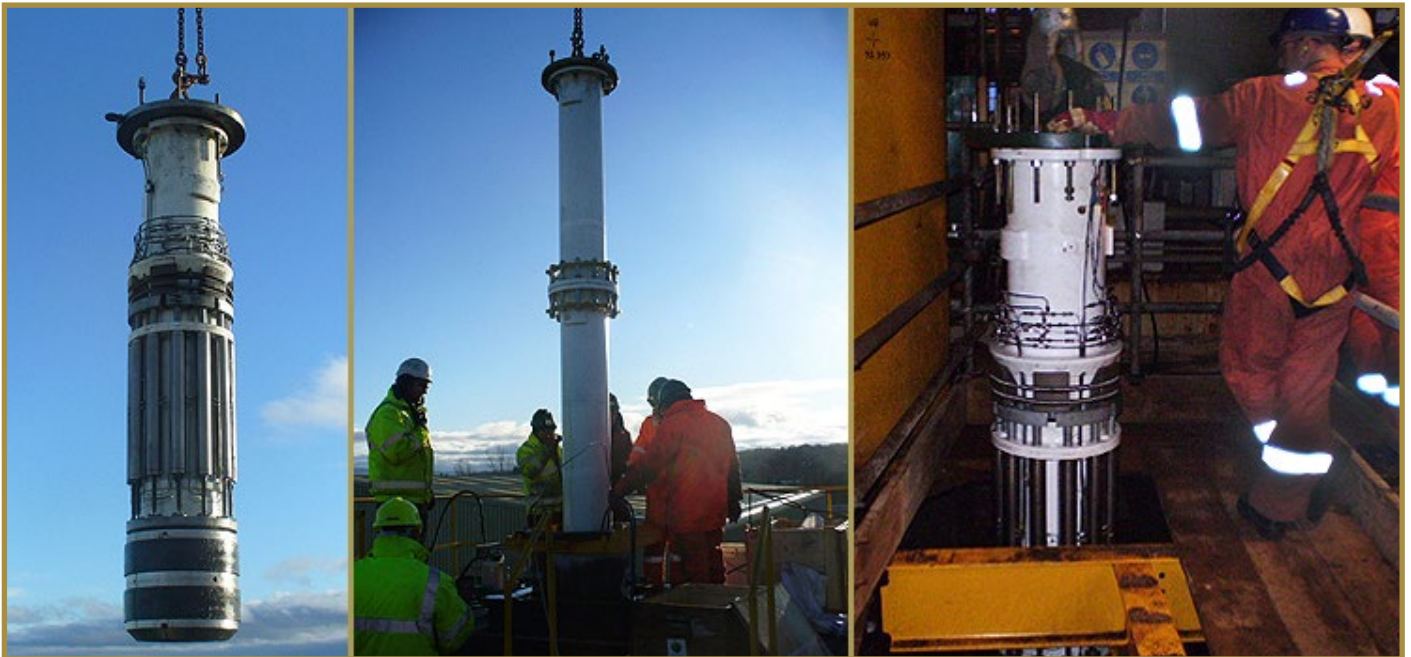
- Requirement to install a liner into an existing 98m long 24" OD caisson, to accommodate water discharge
- Requirement to seal caisson / liner annulus space
- The caisson could not be replaced due to worksite height and deck level restrictions
- Caisson Liner required internal corrosion resistance
- Caisson Liner must pass caisson bore restriction at waterline
- Caisson Liner had to accommodate thermal expansion

- Carbon Steel spools manufactured in suitable lengths to allow for the space restrictions on the installation deck
- Overall finished length of liner 95 metres
- Spools internally clad with Inconel 625 to address internal corrosion issues
- Hydraulically operated dual seal and lock arrangement on base section of liner
- Lower liner spools with reduced 14" OD slip-on flanges in order for spools to pass the bore restriction
- Liner upper section allowed for thermal movement with a sliding sleeve arrangement
- 8 off Inconel control, actuation and injection lines incorporated
- In-house assembly of the whole liner to check for straightness and flexibility
- Successful completion of the job safely and ahead of schedule
